SBE16 Tallinn and Helsinki Conference; Build Green and Renovate Deep, 5-7 October 2016,
Tallinn and Helsinki

Pending for renovations: Understanding the conditions of the multi-family housing stock from before 1945

Pär Johansson^a*, Paula Femenías^b, Liane Thuvander^b, Paula Wahlgren^a

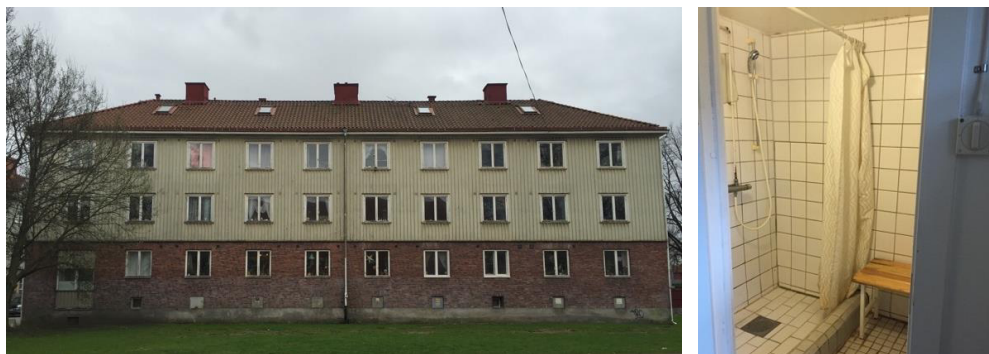
Case 1, Fig. 4, is built in 1929 and has not been renovated apart from smaller repair. The building is not categorized as housing but rented by the city as such. The standard is very low. Only four larger apartments out of approximately 20 have bathrooms, the rest have common showers in basement and shared WC on each level. The tenants profit from very low rents but they have pay high electricity bills as the building is only equipped with electric heating. It was supposed to be demolished to make way for a new plan for the area. The plan is now to renovate the building for continued function as housing. Workshops have been carried out in order to understand the tenants' expectation for an up-coming renovation. Tenants complain about draught, high electricity bills but are otherwise satisfied with the low standard and the high level of social interaction between tenants.

Fig. 4. Case study building 1 is a Landshövdingehus on Banérsgatan 6. Left: façade with brick on ground floor and wooden weather board on the upper two floors. Right: common shower in basement.

There is no energy performance certificate for the building but after an ocular inspection it was concluded that the building is poorly insulated. Some of the tenants' electricity bills have been retrieved which point to a possible energy use of over 200 kWh/m². A number of windows have been exchanged, mainly to units of two panes. However, both newer and old windows are in poor condition and our view is that all windows are in need of renovation. The façade consists of brick and wood, see Fig. 4. The brick is in good condition in most places but the wooden part needs painting. On the interior, some water leakage into the attic was detected. Further investigations need to be performed to determine whether the leakages are old or ongoing. On the first floor, some of the internal brick walls have been severely damaged by water. There seem to be water suction through the basement floor, which also has resulted in biological growth. The common bathroom is in bad condition, with for example cracked tiles. Interior surfaces need to be painted, plastered or replaced.

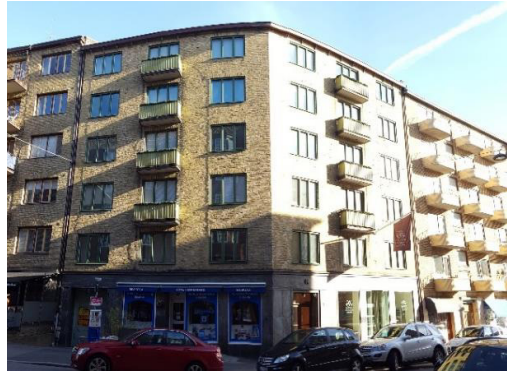
The building built in 1932, see Fig. 5, is located on Geijersgatan in the centre of Gothenburg. The area as a whole is protected and 'represents an excellent example of the late 19th century upper-class urban areas and is one of the country's most well-preserved environments of this kind' [13]. The building was and is consisting of dwellings on the upper floors and shops on the ground floor. It is situated in a bend of the block with the façade facing the street pointing at south and south-east. The inner courtyard is facing north, north-west. The façade is a yellow brick, most likely the same brick type is used consistently in the construction. The inspection of the façade indicates large exposure to weather and wind, since exterior damages can be seen on the façade facing the street. The condition of the bricks was better on the façade towards the courtyard than on the other one.

The façade facing the street has an extra window pane added on the inside of the existing windows. The original window frame was kept and with an external cover layer so that the wooden frame is no longer visible, but the original shape of the window remains. The walls are unchanged with the original brick wall with different thickness dependent on the floor level. The façade facing the inner courtyard is not so different from the façade towards the street. There is no added insulation, the window construction is the same as for the other façade. The entrance doors of the building are original from 1932. The foundation is a crawl space underneath the bottom slab due to uneven excavations underneath the building. The roof of the building was replaced due to water leakage. The original structure of the roof was kept and slightly improved with a double layered roofing felt. The roofing tiles are made of slate [11].

Fig. 5. Case study building 2 is a brick building located on Geijersgatan 14.

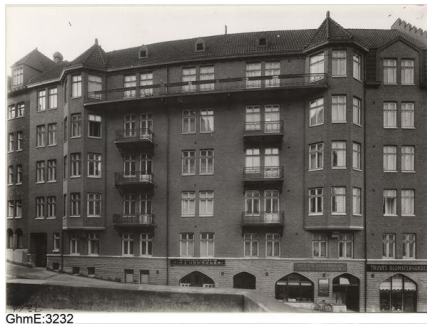
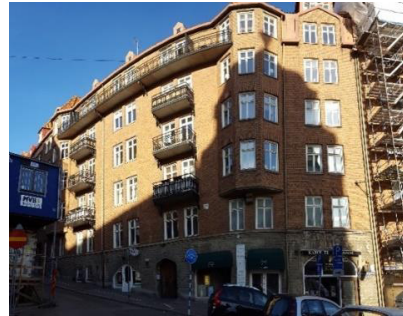
The more renovated building, see Fig. 6, is situated in the inner city of Gothenburg and was built in 1929. The building contains rental apartments. Today the bottom floor consists of two shops and one restaurant. The façade facing the street is original with red bricks and the entrance doors are original. The attic has partly been re-constructed to create additional apartments. The only apparent exterior change is new dorm windows in the new attic seen in the far left in the picture, a change that has been approved by the Museum of Gothenburg. There is still a small unheated attic on top of the apartments, close to the ridge.

The original windows were changed around 1980, but the original windows were kept in the stairwell. The newer windows are chosen with the same design as the original in order to respect the architecture. On the façade facing the courtyard, 100 mm mineral wool was added on the exterior which was plastered. This added insulation unfortunately covers detailing on the eaves. The windows were kept in the same depth in the wall construction after the insulation was added. Many of these kind of houses had stucco on the façades heading to the yard in original. Therefore it is hard to say how far the façade is from its original appearance after the insulation was added. The only interior changes are re-painting and new wall papers [11].

Fig. 6. Case study building 3 is a brick building of National Romantic style located on Föreningsgatan 34. Left: Photos show before (left) and after (right) renovation.
